Document Description: Welch Allyn Service Tool Partner Connect Incorrect Firmware Solution	Document Number: 80027853 Version: A

Customer Service Bulletin

Product: CVSM, CIWS, CP150, ProBP 3400, CSM	Date: 2021-01-14
Subject: Welch Allyn Service Tool Partner Connect Incorrect Firmware Solution	
HW Version(s) Affected: All	SW Version(s) Affected: All
Serial Numbers Affected: All	Lot or Date Code Affected: All

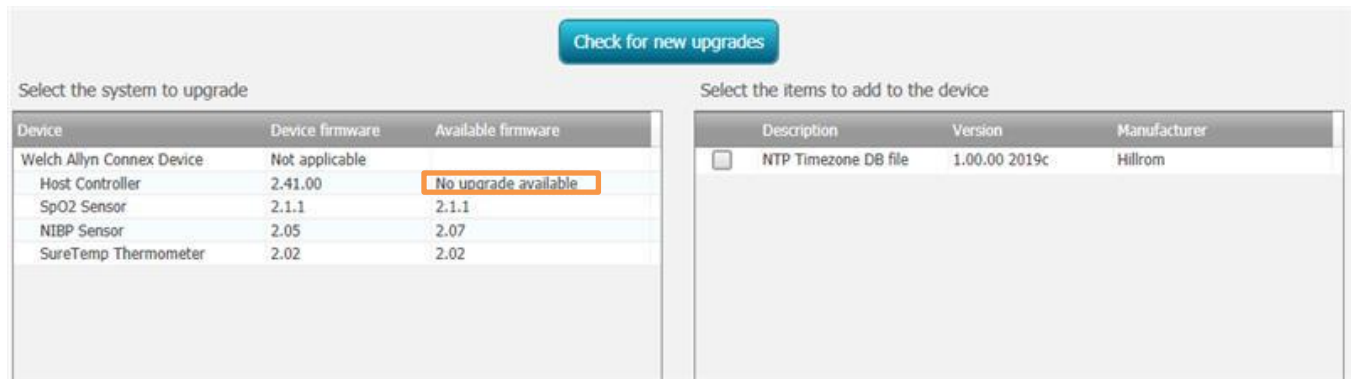
As a Hillrom™ Welch Allyn® Service Tool user, this letter informs you that we have updated our cloud service provider for the Partner Connect Platform. If the Welch Allyn Service tool displays the wrong (or doesn't show) a firmware package version, please follow the following steps to correct the issue.

Example: CVSM missing available firmware

1. In your browser please go to: <https://t128564.iot.hillrom.com/inventory/binaries/34342509> If this is not accessible and displaying a login prompt please contact your IT Department to open up the appropriate port.
2. Navigate to: C:\Program Files (x86)\Welch Allyn\PartnerConnect\Firmware\ and please delete the firmware version affected.

3. Navigate to: C:\ProgramData\Welch Allyn Service Tool\Inbox\ and delete all XML files.

4. Once this is done, please contact Welch Allyn Technical Support to re-deploy (if applicable) device firmware.
